# Manhole Inspection Summary

Manhole # S13CC\_027MH

**Location** Address: **REAR 1116 POPLAR GROVE ST** Cross Street: **WINCHESTER ST**

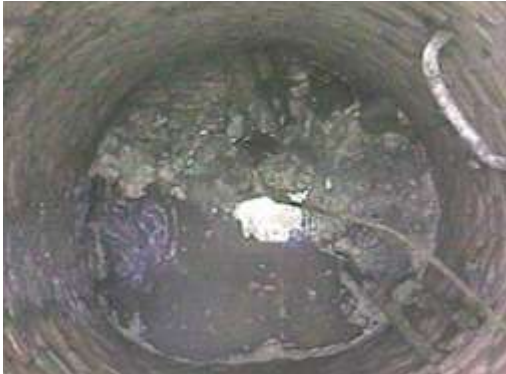
Defect 1

Condition: ☐ Sound ☐ Cracked ☐ Root Intrusion ☐ Deteriorated ☐ Leaks ☒ **Debris**

**Surcharge** ☒ **Evidence Of Surcharge** Depth: **0.5** (ft.) ☒ **Active Surcharge Present**

DEBRIS IN CHANNEL AND EVIDENCE OF ASUR

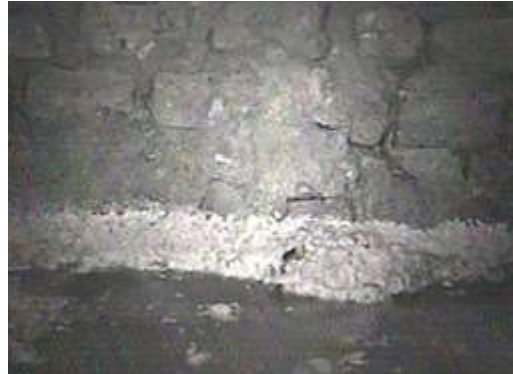
Defect 3

Condition: ☐ Sound ☐ Cracked ☐ Root Intrusion ☐ Deteriorated ☐ Leaks ☒ **Debris**

DEBRIS AT BENCH

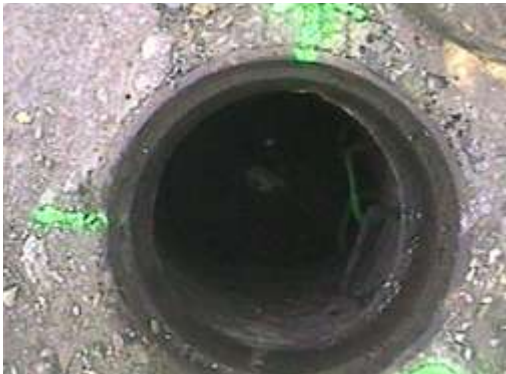
Defect 2

**Frame** Offset: **2** (in.) Condition: ☒ Sound ☐ Cracked ☐ Leaks

FRAME OFFSET

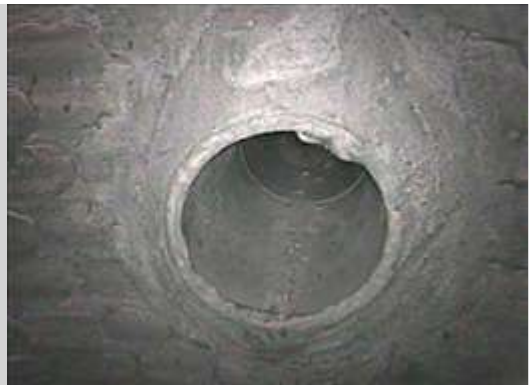
6 O'Clock Inflow

FRAME OFFSET

Pipe Height: (in.) Direct  
Pipe Material: **Clay** ☐ Pipe Lined  
Invert Depth: **7.20** (ft.) Flow Characteristics: **Slow**  
Deposits: ☐ None ☐ Mud ☒ Sludge ☒ Debris ☒ Grease  
Silt Depth: **8** (in.) Deposits Extent: **Heavy**  
Infiltration: **None** Pipe Seal Cond: **Unknown**

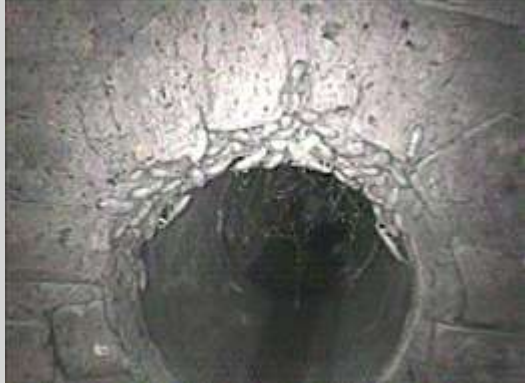
9 O'Clock Inflow

FRAME OFFSET

Deposits: ☐ None ☐ Mud ☐ Sludge ☐ Debris ☒ **Grease**

Silt Depth: **1** (in.) Deposits Extent: **Light**

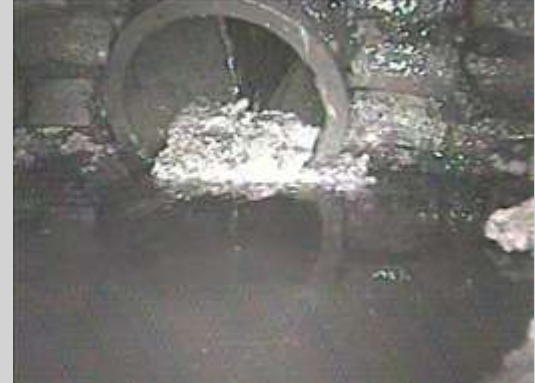
Drop In @ 9 O'Clock

FRAME OFFSET
